The
San Francisco Earthquake and Fire

A BRIEF HISTORY OF THE DISASTER

A. L. A. HIMMELWRIGHT, C.E.

THE ROEBLING CONSTRUCTION COMPANY
FULLER BUILDING, NEW YORK, N. Y.

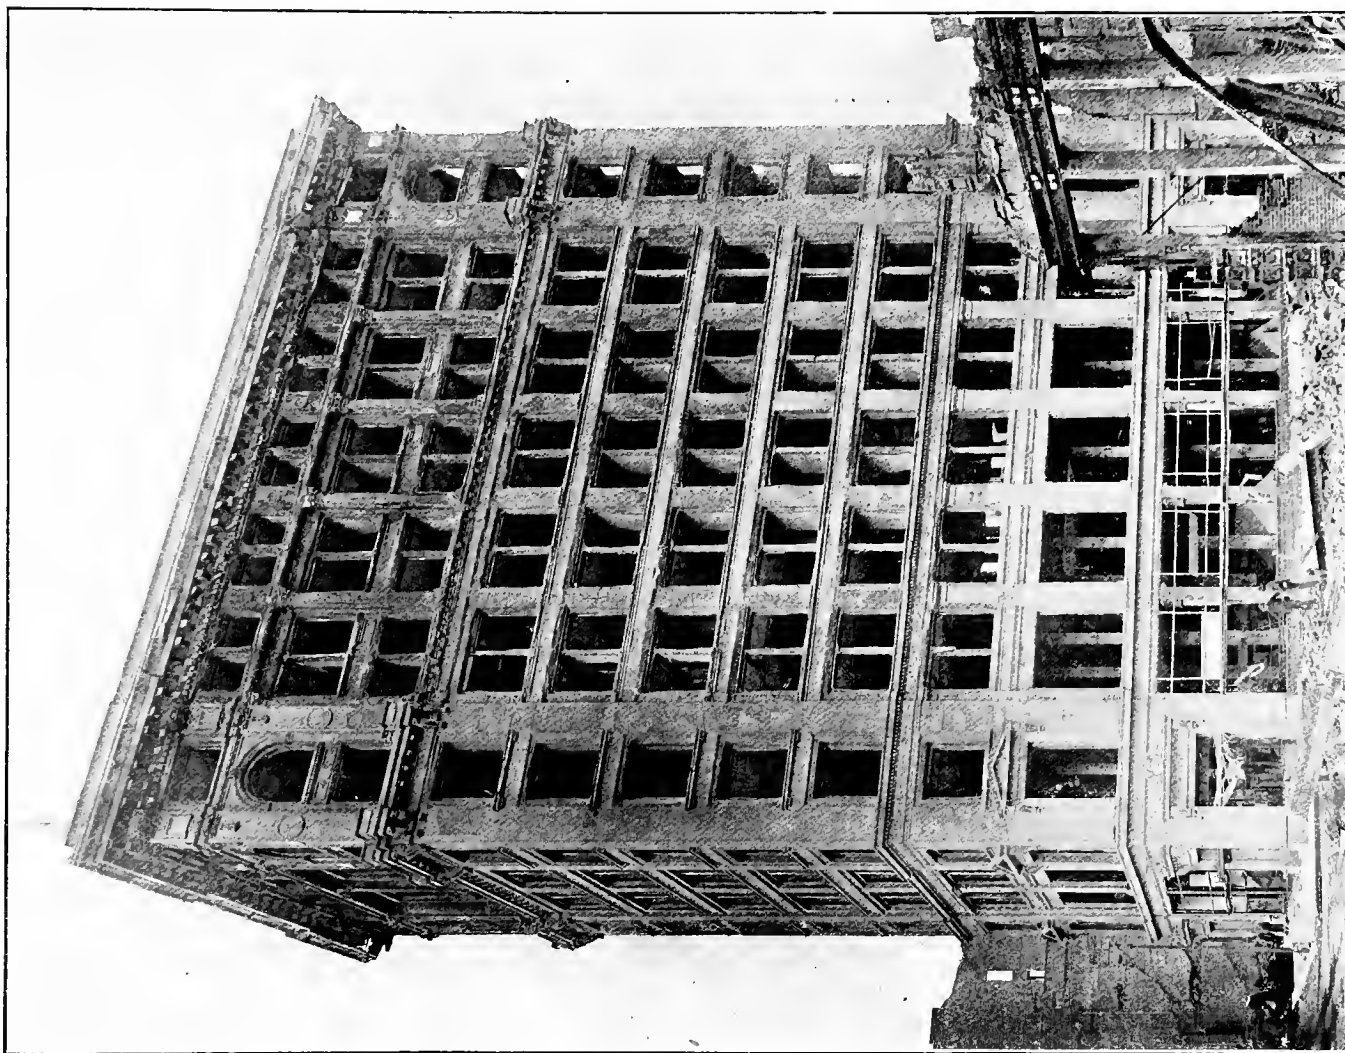
The sand-stone of the Post Street front is spalled by the fire around the window openings, the worst damage being done on the west side. On the Grant Avenue side, the entire front is badly spalled by the fire. The ornamental columns at the ninth and tenth story levels are badly damaged. The north front of the building is totally ruined by spalling. The excellent work of anchoring or bonding the veneer to the backing is shown by the fact that in some cases only thin shells of the sand-stone remain in position. The corners of this front, at the east and west sides, are damaged and cracked. The metal cornice is wrecked. The west wall of common brick is in good condition. At the second floor level at the northeast corner is a small crack, the only earthquake crack visible in any of the walls of this building. The entire steel skeleton frame is absolutely uninjured.

The levels on the water table indicate that the foundations are in good condition. The greatest observed variation of the walls from the plumb is at the southeast corner, where the east wall leans to the east about $\frac{1}{2}$ " at the top. At the southwest corner, the south front of the building leans to the south about $\frac{1}{4}$ ".

The concrete floors and flat wire lath ceilings throughout the building are in first-class condition. The concrete column covering in the basement, first and second stories is uninjured. The hollow tile covering from the third story to the top is considerably damaged, having fallen away in many places. Some of the damage to the tile column protection was caused by bulging pipes. The partitions generally are greatly damaged and a large proportion has fallen down.

SHREVE BUILDING. Showing the Grant Avenue elevation. The façades consist of gray sand-stone. The entire Grant Avenue side is badly spalled by the fire. The ornamental columns at the ninth and tenth story levels are slivered. The metal cornice is wrecked. The Post Street front is spalled around the window openings, the worst damage being on the west side. There is very little earthquake damage. The Roebeling concrete floors and wire lath ceilings throughout are uninjured. The Roebeling concrete column protection in the basement, first and second stories, is also in first-class condition, but the 3" hollow tile column protection in the upper stories is considerably damaged, having fallen away in many places. The 4" hollow tile partitions generally are in bad condition, and a large proportion have fallen down.

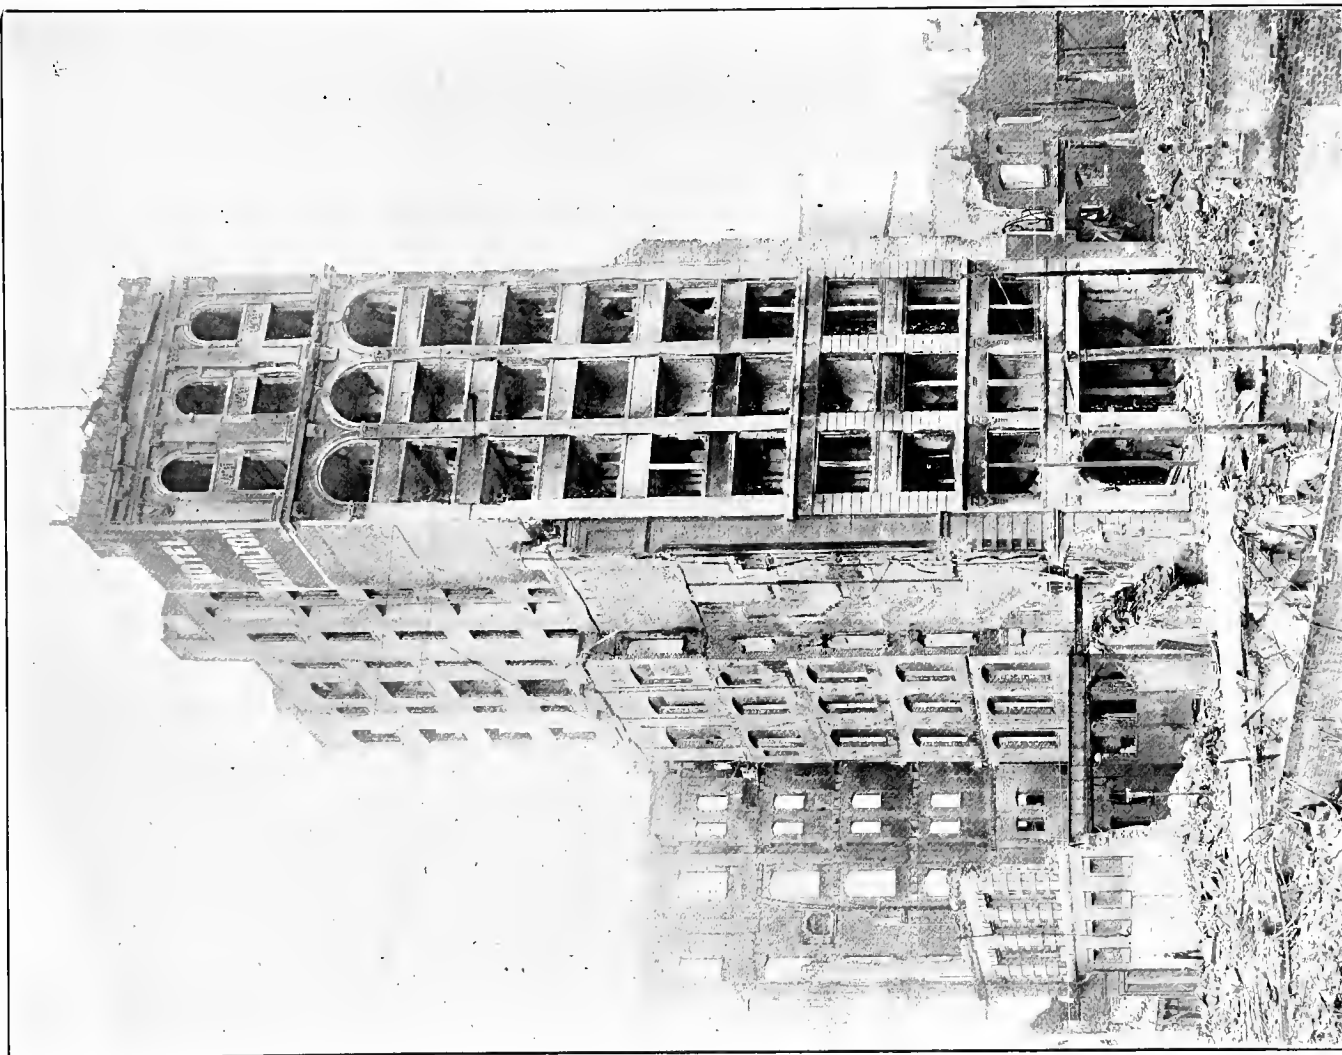
The sand-stone in the lower stories is but slightly damaged by the fire, there being a little spalling around the window openings. In the upper stories, the terra cotta is considerably damaged by the fire. The metal cornice is down. The west wall of common brick is apparently in good condition, and has no serious earthquake cracks. The east wall is in fair condition, but the face brick are apparently loose from the backing at the eighth, ninth and tenth story levels.

The levels on the water table indicate that the foundation is not damaged. The greatest observed variation of the walls from the plumb was at the southeast corner, which leans approximately 1/2" to the north.

Although the fire in this building was simply normal, and such as would ordinarily be expected to occur in a hotel building, the steel frame is considerably damaged. In the first story, five columns are buckled in the middle portion of the building. In the sixth and seventh stories, a column is buckled west of the elevator shaft. The steel framing around the stairway wells, and the vertical framing of the elevator shaft, are considerably distorted by expansion.

HOTEL HAMILTON. South Side of Ellis Street, between Mason and Powell Streets. The façade, consisting of sand-stone and terra cotta, is considerably damaged, and the metal cornice has fallen away. All of the side and rear walls are more or less damaged by earthquake cracks. In the first story five columns are buckled in the middle portion of the building. Two other columns are buckled in the sixth and seventh stories, west of the elevator shaft. The column failures were caused by flimsy and insufficient furring for the wire lath and plaster. The Collins concrete floors are in good condition. The double lath and plaster partitions, with the Collins slotted stud, are in bad condition, on account of the light gauge stud and the wood stringers to which they are fastened top and bottom.

The failure of the columns was undoubtedly due to the column protection, which was of very flimsy construction. The furring around the columns to support the lath and plaster was very light and inadequate for the requirements.

The repairs required for the exterior of this building will be comparatively slight. The buckling of the columns referred to has caused the floors throughout the entire building to settle. It may be possible to correct this settling and replace the damaged columns without reconstructing the building, but it will be a difficult and expensive operation.

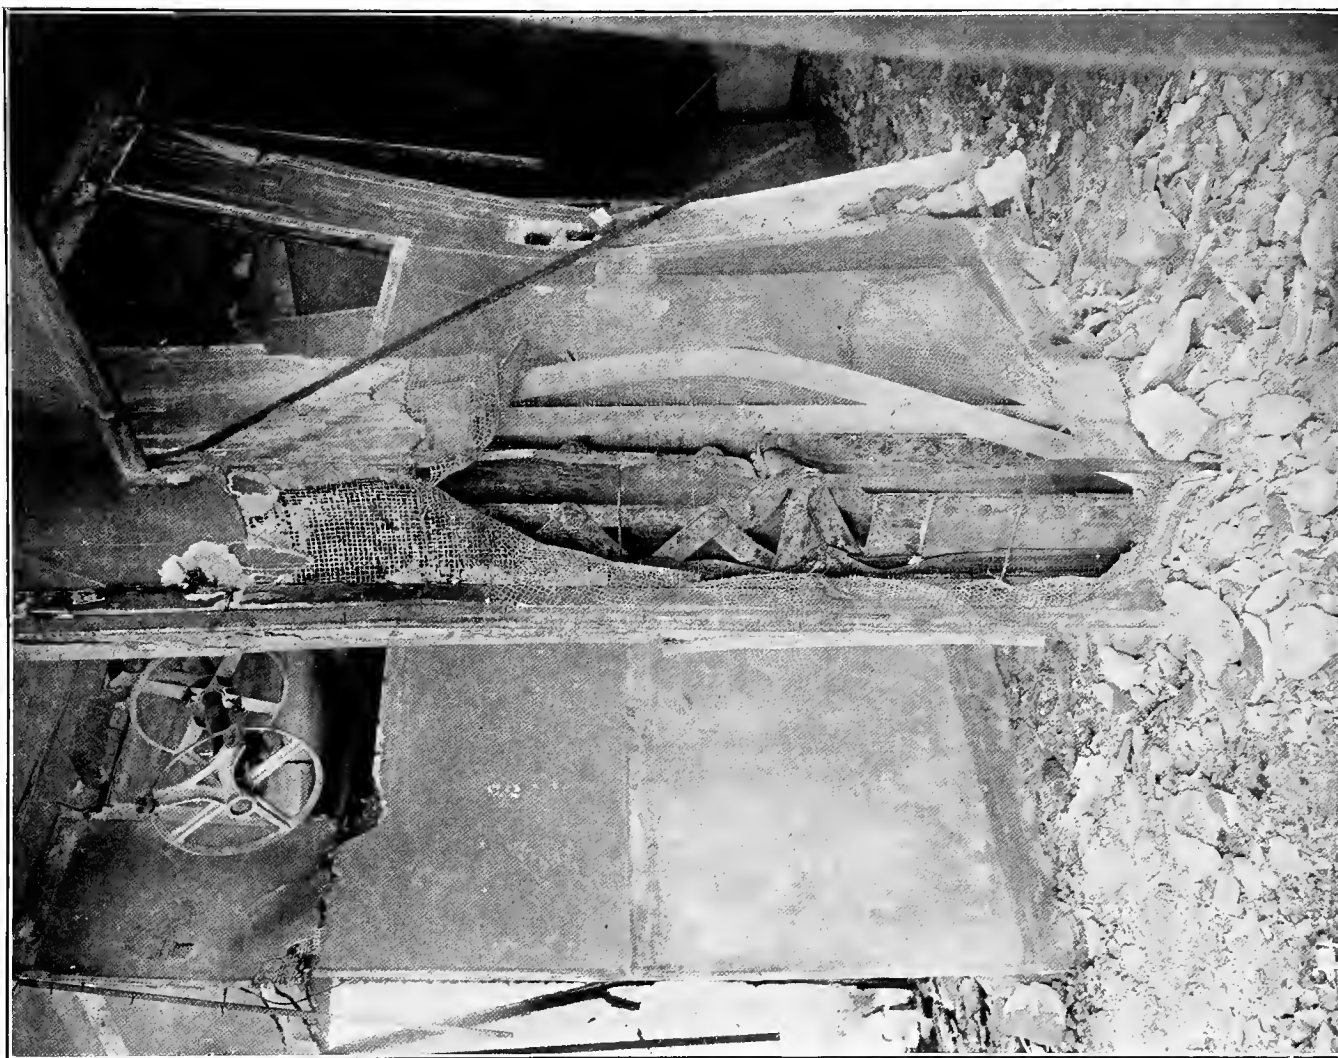
HOTEL HAMILTON. Twelfth Story. Showing a buckled column and the flimsy manner in which it was protected. Only a few light rods were used for the furring and these did not anchor the protection to the column. Note the deflection of the partition due to the settling of the column.

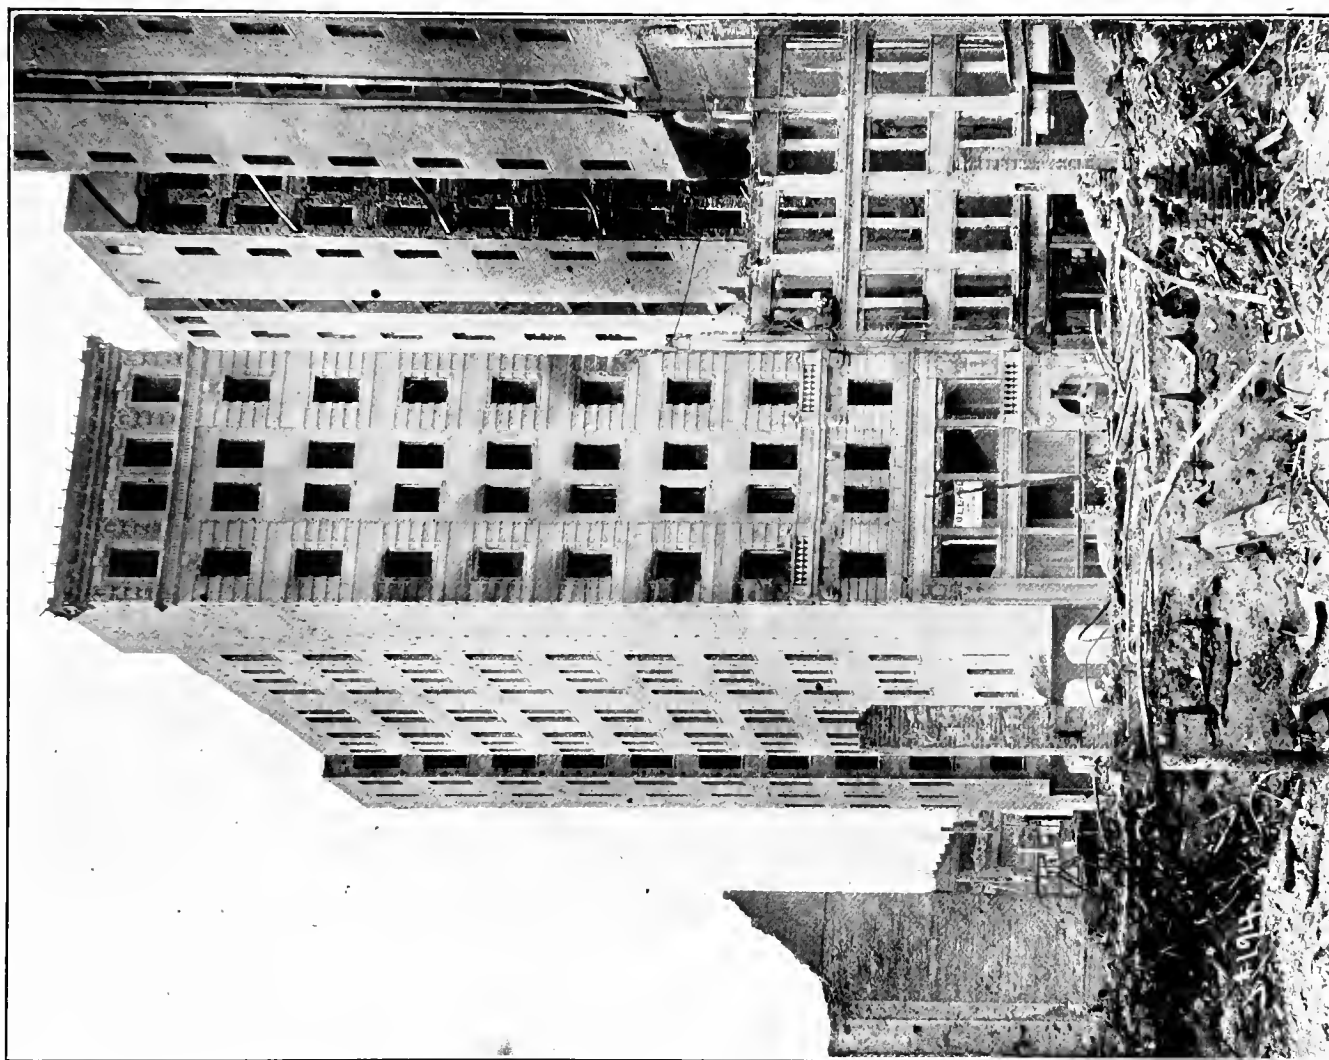
This building was subjected to a normal fire. The front of the building shows no earthquake cracks and is not seriously damaged by the fire. There is considerable spalling around the window openings from the fourth to the eighth story, and also at the eleventh story. The metal cornice is damaged. The east and west walls of common brick are apparently in good condition. The rear wall has been injured in spots by the falling of the wall of an adjacent building.

The levels on the water table indicate that the foundation at the front of the building is level. The greatest observed variation of the walls from the plumb is at the southwest corner, where the south front leans to the south about 1/4".

The concrete floors, notwithstanding the warping of the floor surfaces on account of the buckling of the columns, are in good condition. The wire lath and plaster ceilings are loose and partly down at some places. A lot of brick work from a falling wall back of this building fell through the large window openings in the rear, but did no apparent damage to the concrete floors.

HOTEL ALEXANDER. Geary Street, between Powell and Mason Streets. The façade of sandstone is only slightly damaged by spalling around window openings. The metal cornice has fallen away. Although subjected to only a normal fire, columns have buckled in the third, fifth, sixth, seventh, eighth, ninth and tenth stories, on account of flimsy methods employed in the wire lath and plaster column protection. Notwithstanding the warped condition of the steel work, the Collins concrete floors remain in place and have been very little damaged by the fire. The 2" wire lath and plaster partitions, with the No. 16 gauge Collins slotted metal studs, are badly deflected and bulged throughout. The illustration shows also a portion of the light court of the Hotel St. Francis which was stripped of the face brick during the fire.

Except for the buckling of the columns, this building would have been practically uninjured structurally. The replacing of the columns will be an expensive operation, and may involve the reconstruction of a considerable portion of the building. The damage to the exterior is comparatively small.

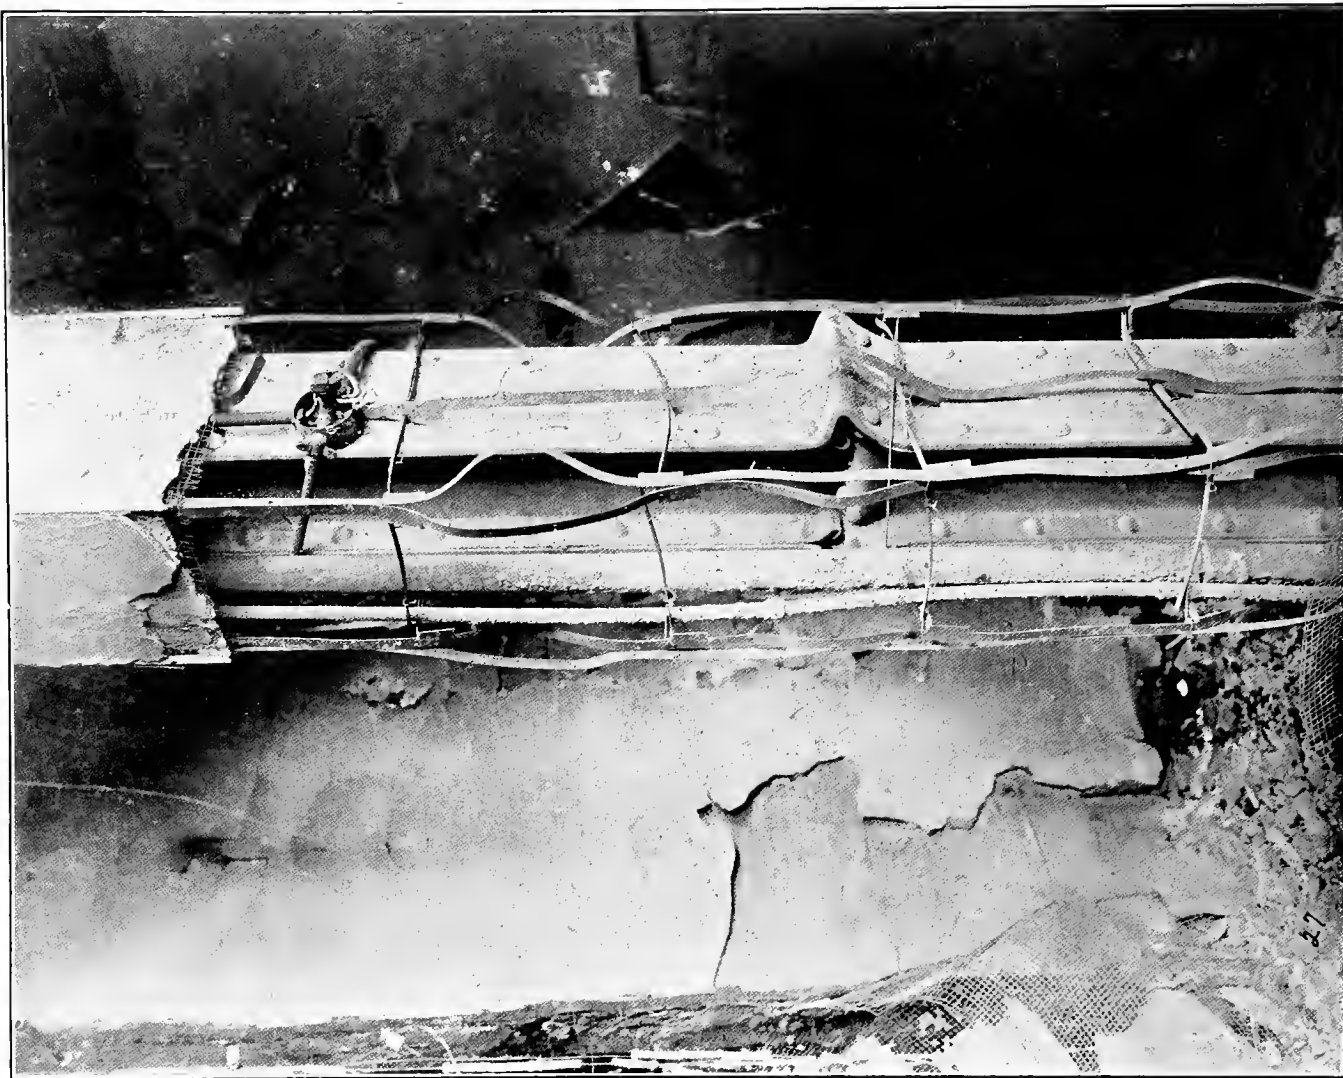
HOTEL ALEXANDER. Buckled column showing the typical method of the furring and lathing for column protection in this building. The light metal furring consisted of No. 16 gauge sheet steel, slotted by the Collins method. Note the excessive buckling and destruction of the furring when such light metal is used for this purpose.

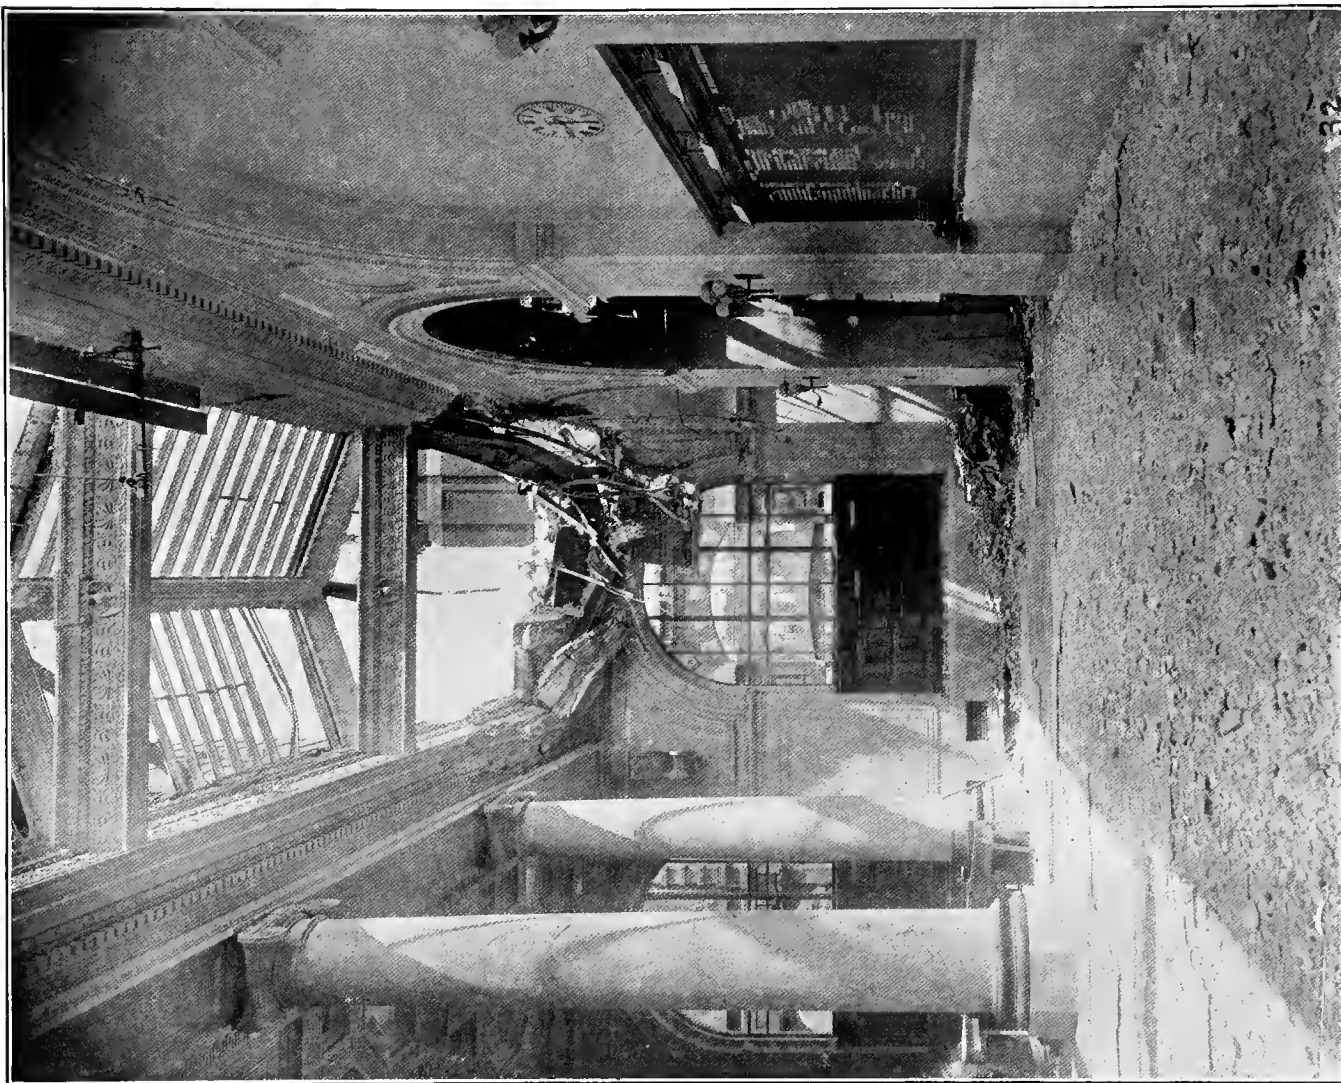
The granite portions of the front of the building are badly spalled at the second story, but is only slightly damaged at the first story. All the rest of the front is in good condition. The west wall of common brick has some earthquake cracks about midway from the top, and at the southwest corner near the bottom. The east wall of pressed terra cotta brick is spalled in spots from a hot fire of an adjacent building near the front. There are earthquake cracks in the third, fourth, fifth, sixth and seventh stories. A falling wall of a building back of the Merchants' Exchange damaged the rear wall and broke down a portion of the skylight over the exchange room.

The levels on the water table indicate that the foundations remain practically level. The greatest observed variation of the walls from the plumb is at the southeast corner, which leans approximately $\frac{3}{8}$ " to the west. The north front at the northwest corner leans to the south only $\frac{1}{4}$ ".

MERCHANTS' EXCHANGE BUILDING. South Side of California Street between Montgomery and Sansome Streets. The façades of gray granite for the first and second stories and buff terra cotta brick with terra cotta ornamentation above, are in good condition, with the exception of the granite, which is badly spalled at the second-story level. The rear walls of common brick are slightly cracked by the earthquake. A falling wall, from a building in the rear, wrecked the skylight and roof over one corner of the exchange room. The steel skeleton frame and the Roebbling concrete floors and wire lath and plastered ceilings are uninjured. The double wire lath and plaster column protection is intact. The Roebbling wire lath and plaster partitions all remain standing, but are deflected out of plumb in some places. Numerous small vaults and so-called fire-proof safes failed to preserve their contents. This building passed through the earthquake and the fire with as little structural damage as any building in the burned district.

This building withstood the effects of the fire and the earthquake admirably and can be repaired without difficulty.

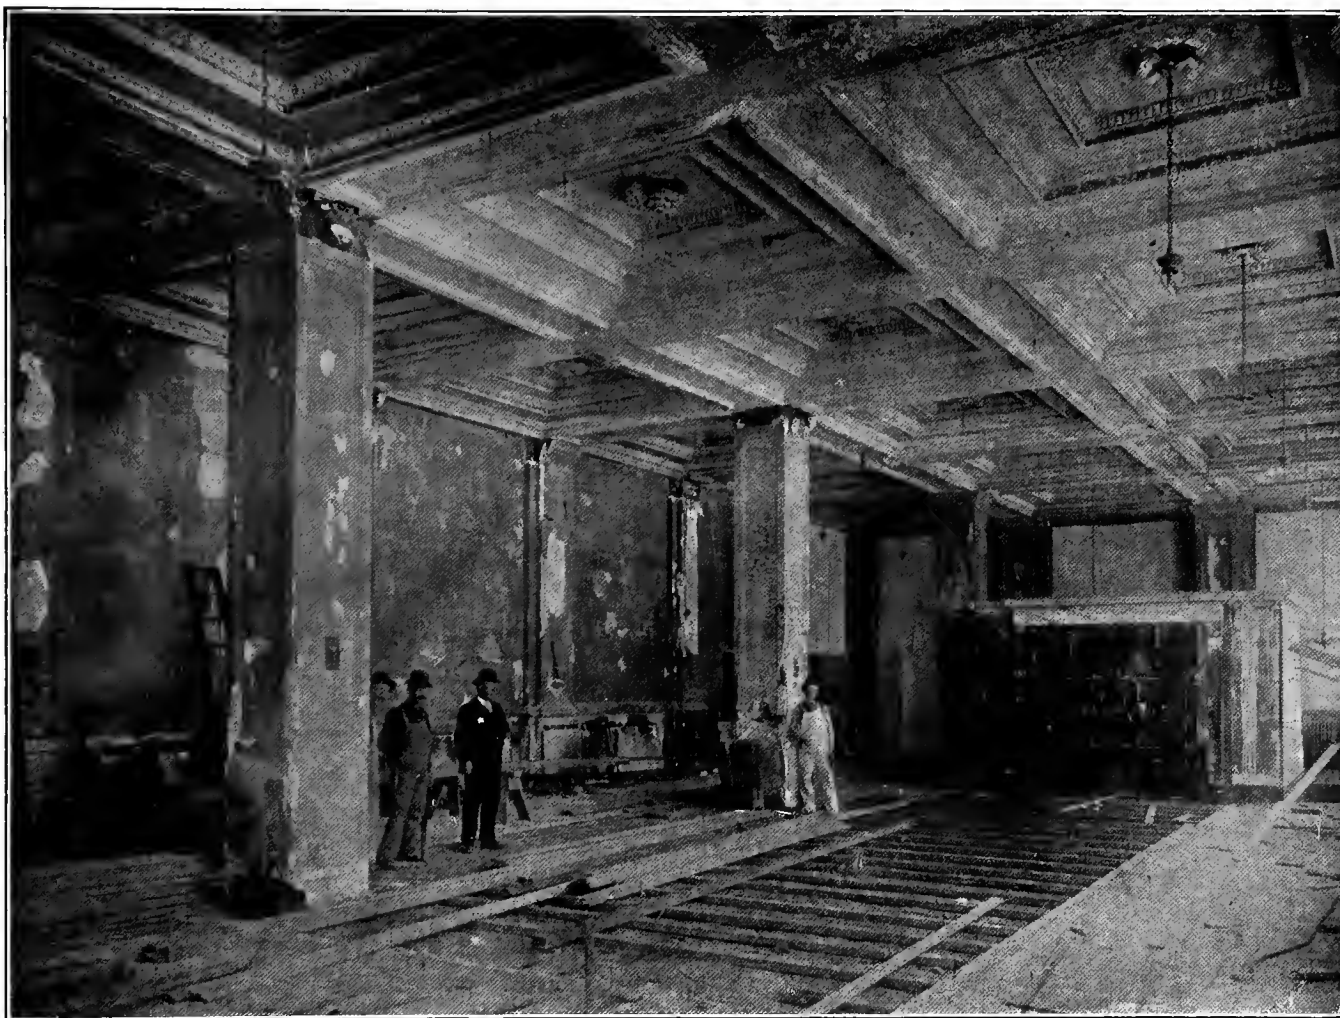
MERCHANTS' EXCHANGE BUILDING. First Story. Showing condition of Roebling fire-proof floors, partitions, column covering and ornamental lath and plaster ceiling in the banking room of the American National Bank. Everything combustible in this room was consumed, the vaults remaining in good condition. A temporary wood floor was being laid at the time that the photograph was taken.

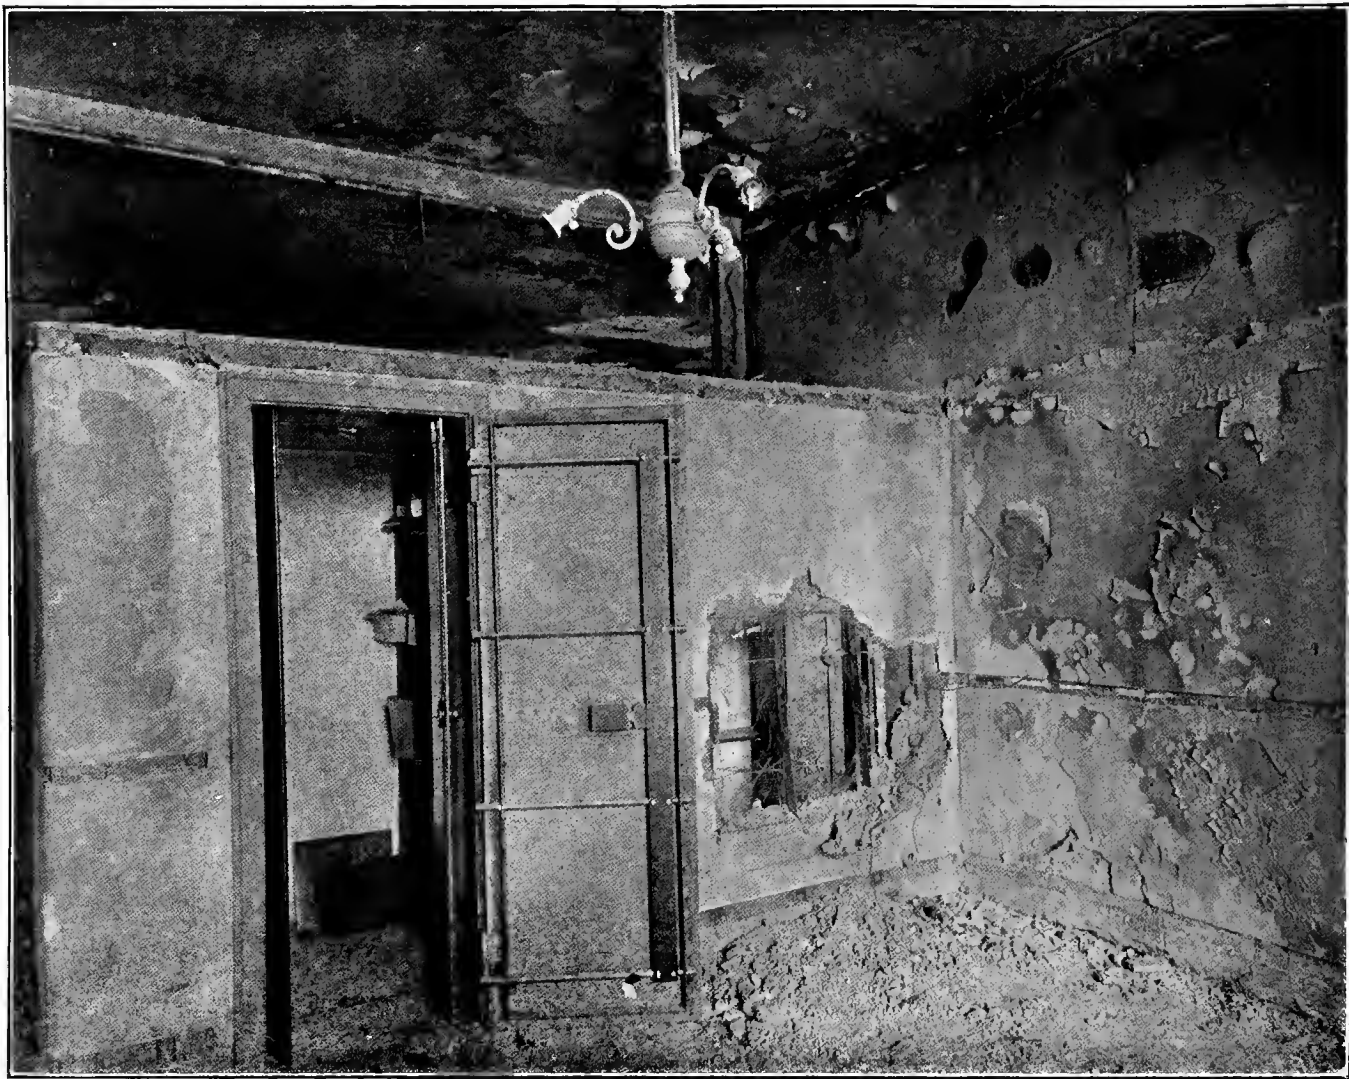
MERCHANTS' EXCHANGE BUILDING. Typical view showing the condition of the wire lath and plaster ceilings and partitions. The safe in the foreground fell over on its side without doing any damage to the Roebling concrete floor. The vault on the right, enclosed by a solid wire lath and plaster partition 2" thick, preserved its contents. The contents of a number of other similar vaults in this building were totally destroyed.

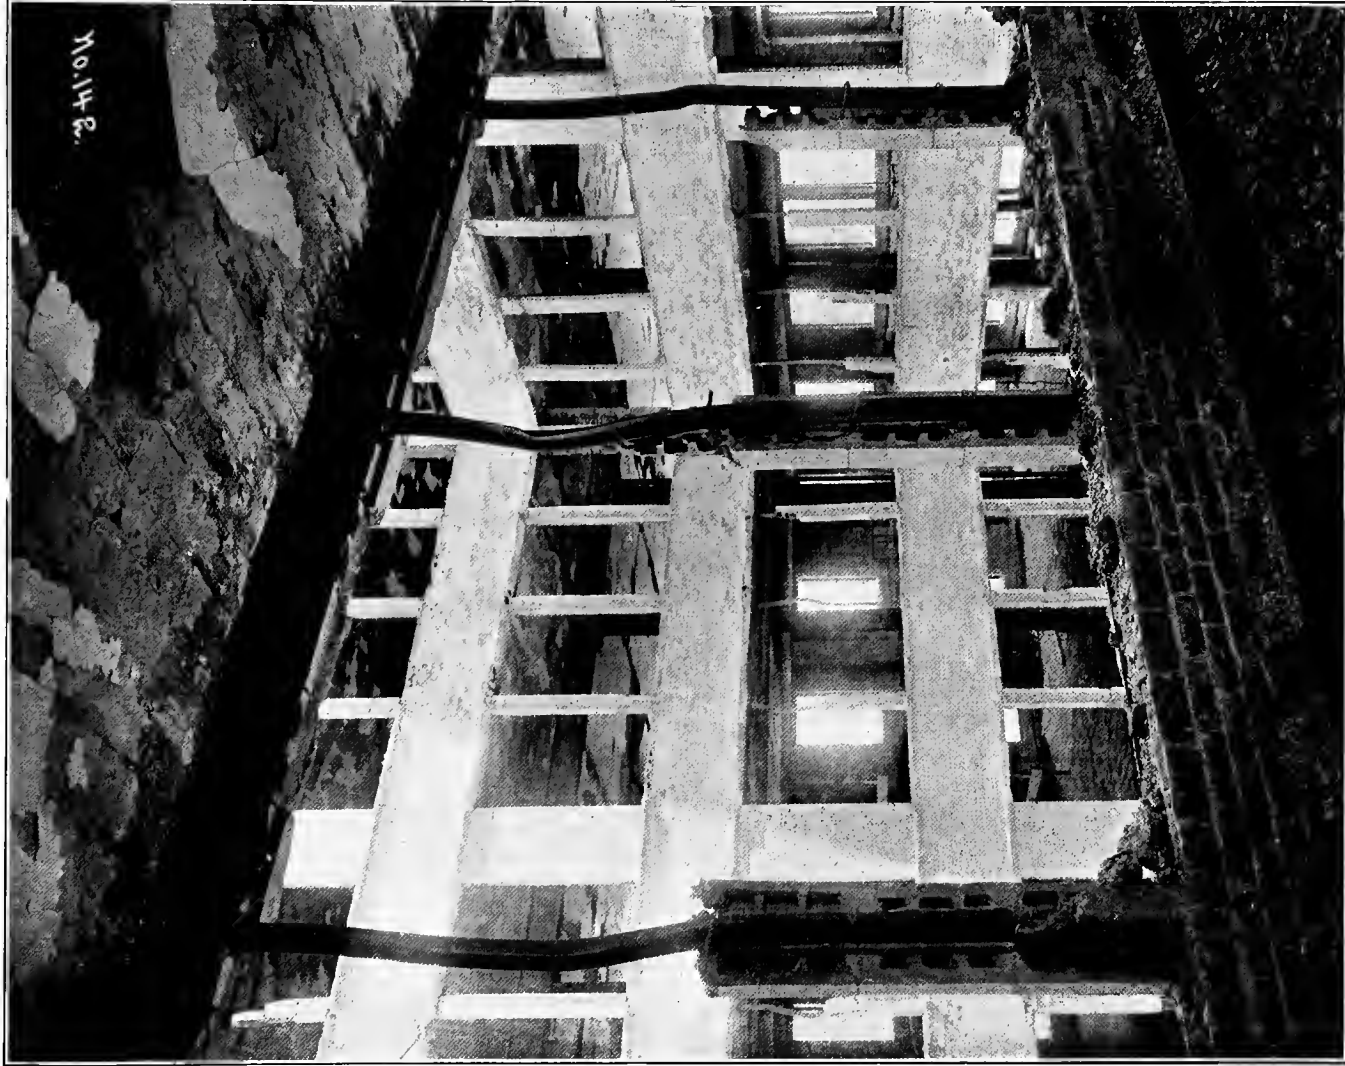
MERCHANTS' EXCHANGE BUILDING. Eighth Story. Showing the buckled and distorted steel supports for mullions. These steel members were rigidly connected top and bottom, no provision having been made for expansion. The buckling and distortion of these members disrupted the terra cotta facing, which fell down breaking the glass and seriously damaging the skylight at the bottom of the light court. The view shows also the distortion of similar steel members on the other side of the court.

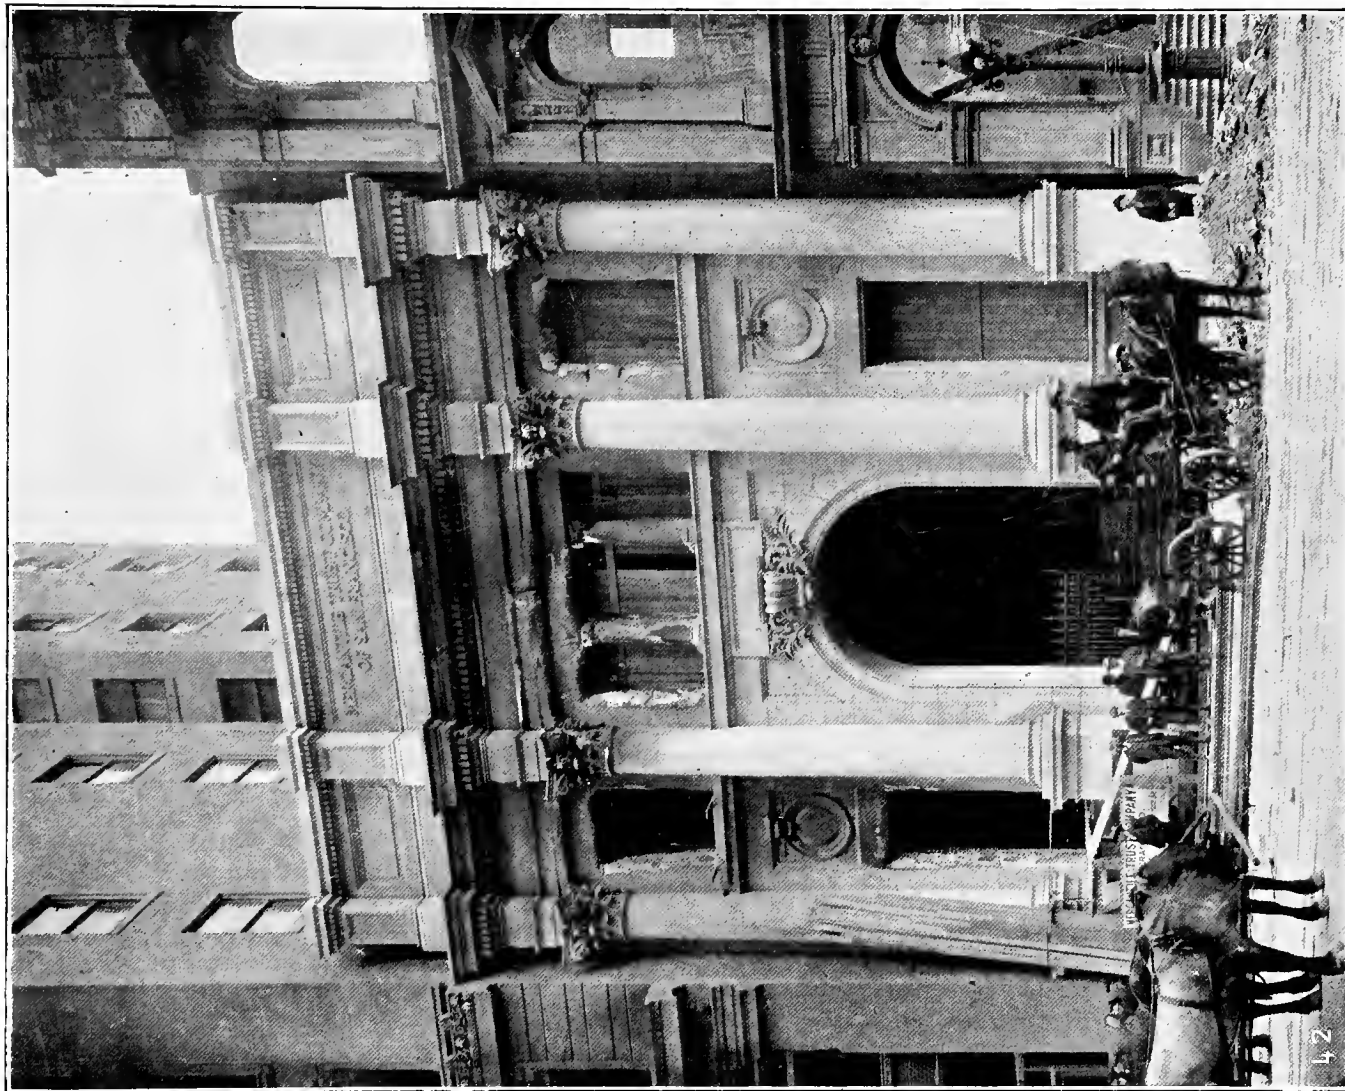
MERCANTILE TRUST COMPANY'S BUILDING.

MERCANTILE TRUST CO.'S BUILDING. North Side of California Street between Montgomery and Sansome Streets. The façade consists of gray granite, which is considerably damaged by spalling around the window openings. The building is structurally uninjured. The fire-proof floors are segmental stone concrete arches. The roof consists of the Roebling system B flat cinder concrete slab. The partitions are of double wire lath and plaster. This building was occupied, pending permanent repairs, a few days after the fire.

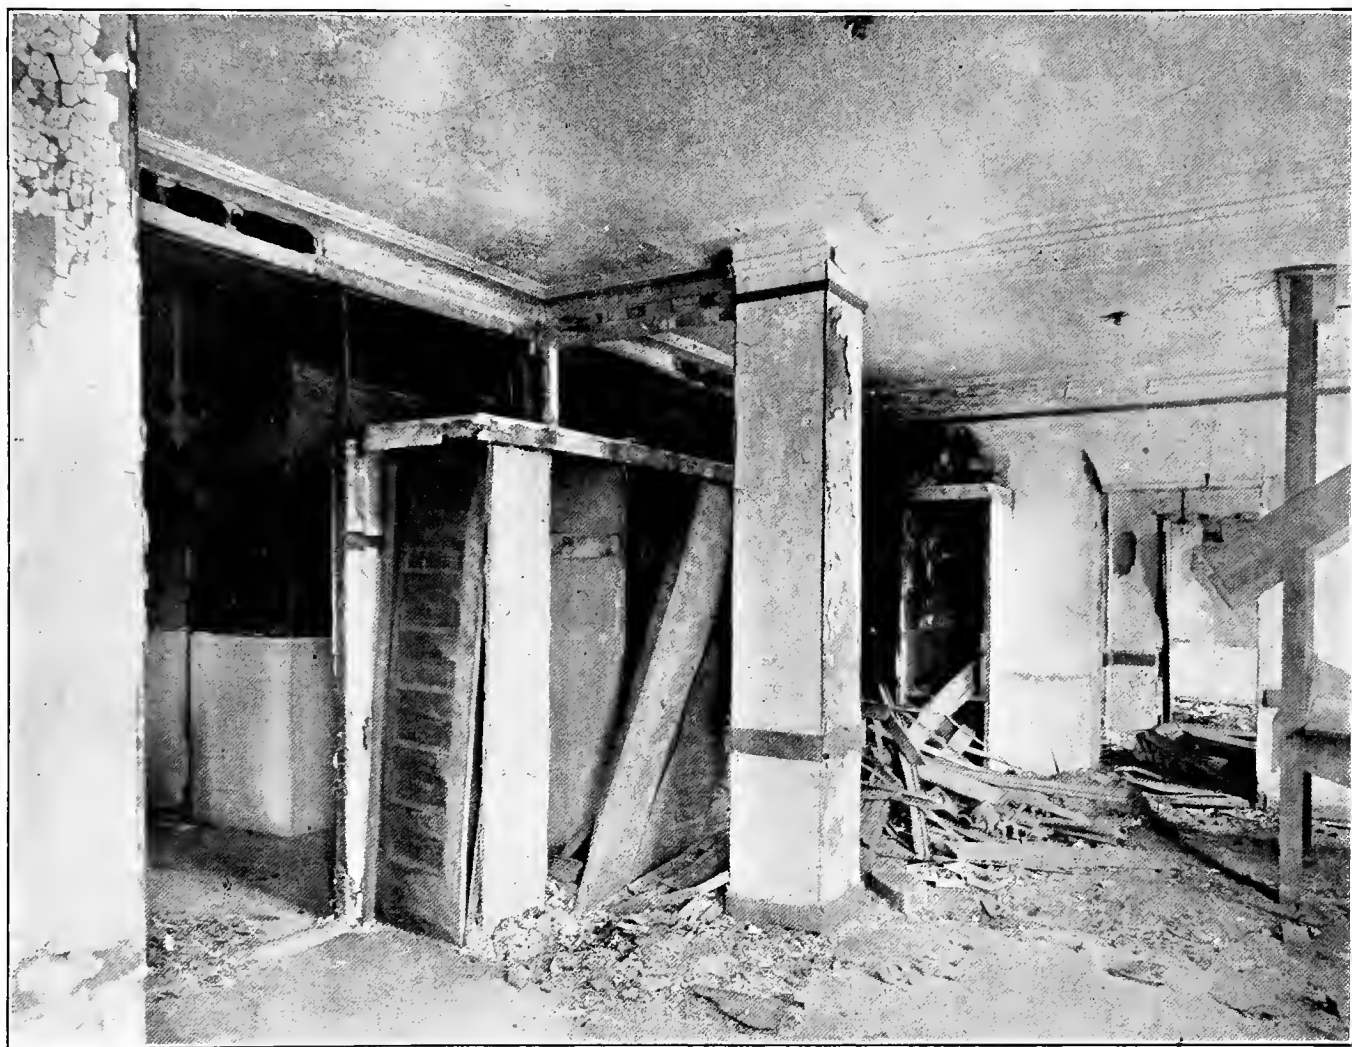
KOHL BUILDING. Typical view of the portions damaged by fire. The metal-covered doors, trim, etc., retarded the fire and prevented its spread in many parts of the building. The floors are of the expanded metal concrete type with a cement finish.

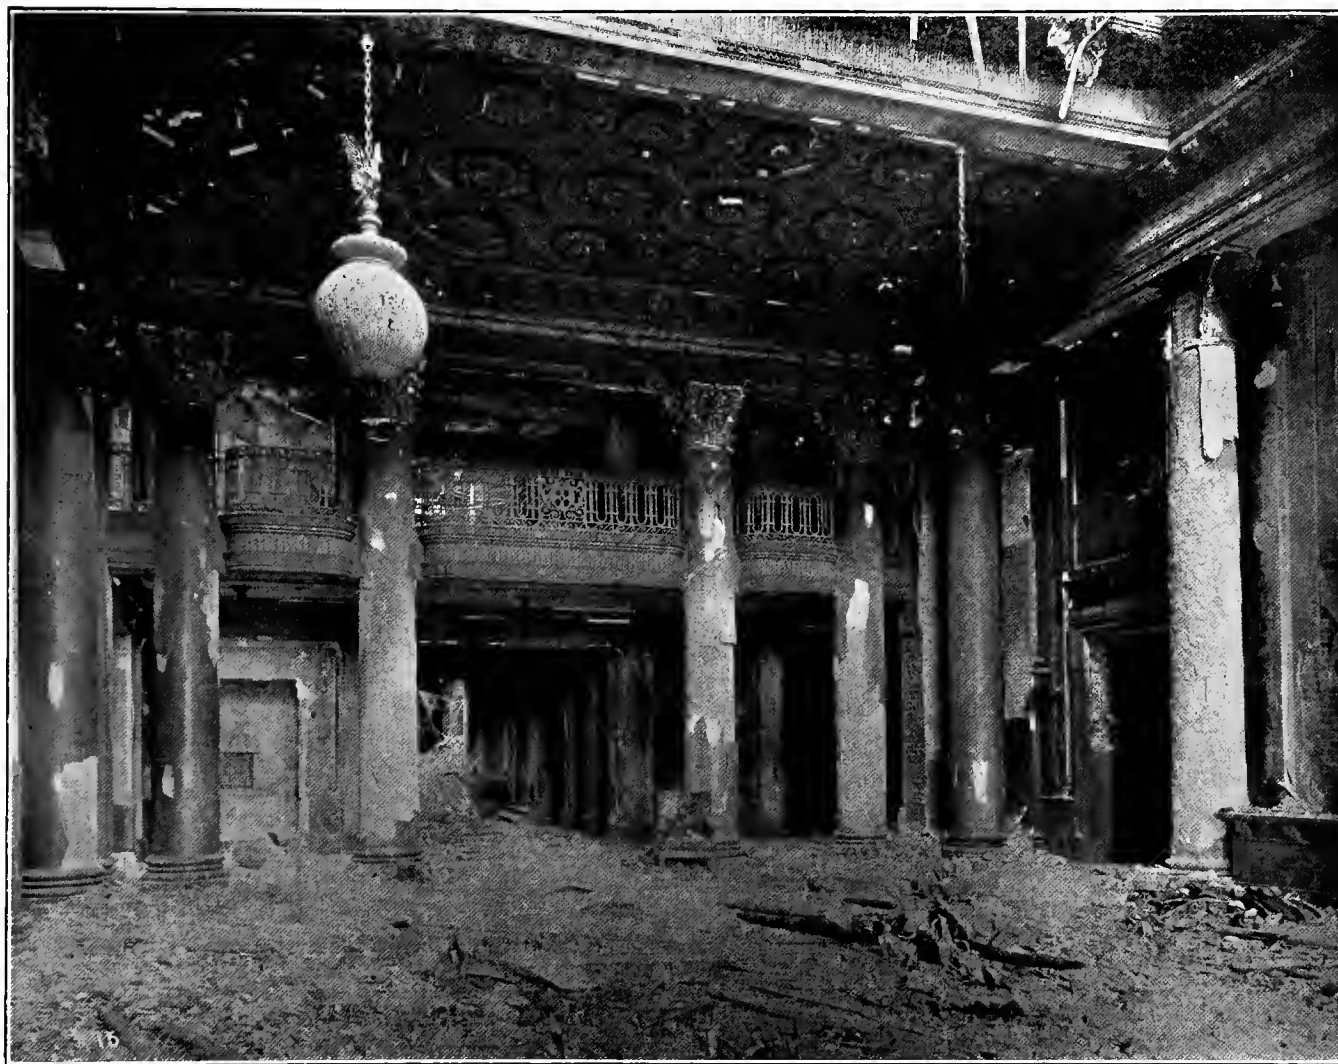
HOTEL ST. FRANCIS. Interior of the main lobby, looking from the entrance. The ornamental effects were produced by the Roebling method of light steel furring and wire lathing. The plaster caps were cast and are badly damaged. The columns are protected with cinder concrete, a defect in the design showing on the right-hand side where the protection was omitted behind the cap near the top. This portion of the building was subjected to a very moderate fire.

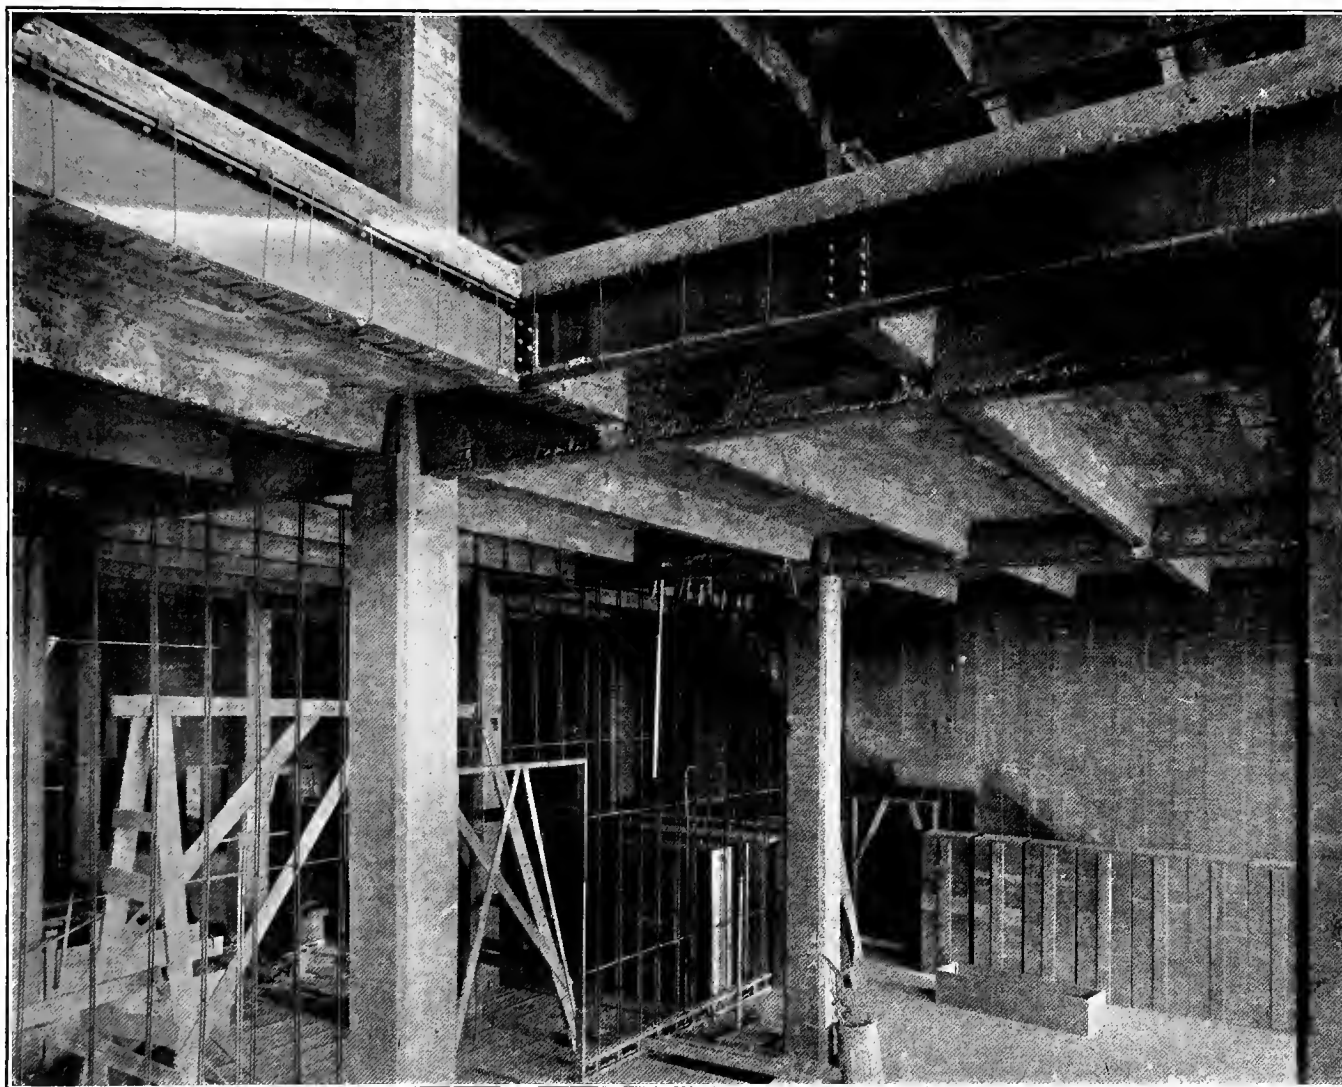
CALIFORNIA CASKET CO.'S BUILDING. First Story. Showing the finished concrete column protection, and the crimped galvanized lath on the soffits of the beams and girders and the exterior wire wall furring ready for the plaster. This building was in the course of construction at the time of the fire and had little combustible contents. All the wood work, such as window frames, scaffolding, etc., was consumed. The merchandise, trestles, etc., shown in the photograph, were carried into the building after the fire.
